## DEGREE IN TECHNICAL ARCHITECTURE AND BUILDING FINAL DEGREE PROJECT

### FIRE SPREAD ACROSS INNER COURTYARDS FAÇADES

**Author:** Esteve Gonzàlez Cuxart

**Call:** April 2020

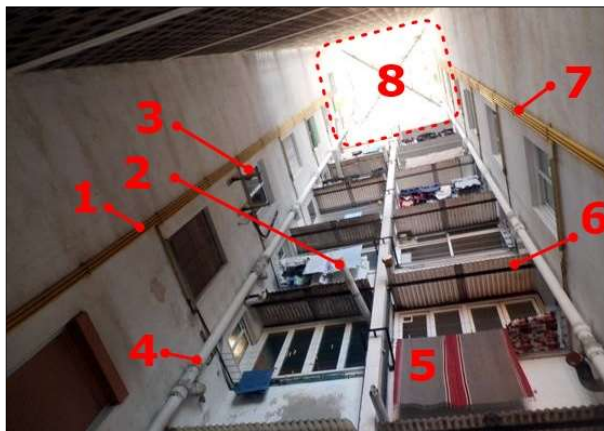
Figure 14. The airy patio of a property located in Ronda de St Pau street in Barcelona (TRAC).

[1] and [7] Copper tubing for natural gas.

[5] Flammable textile material on balconies.

[6] and [8] Plastic light patios.

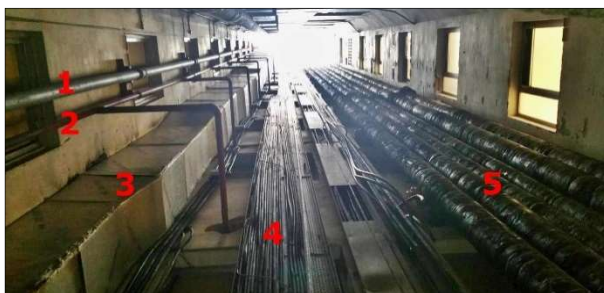
Figure 15. The inner courtyard of a building in Aragó street in Barcelona (Som Habitat).

[1] Dry column galvanized steel tube.

[3] Air pipe conditioning system.

[5] Air pipe conditioning system.

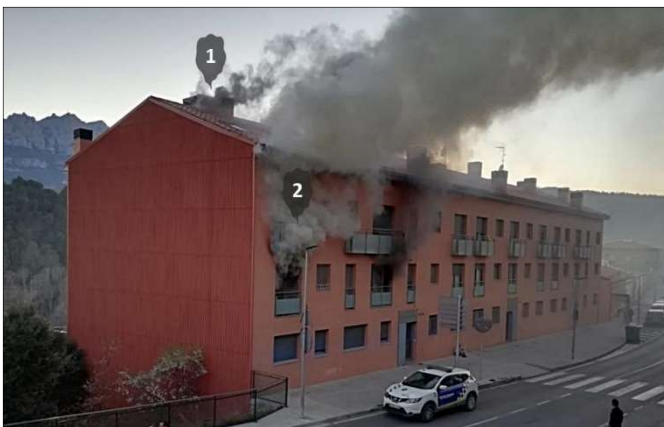
Figure 17. 2019.02.27 Housing fire in Castellvell i el Vilar started at 19:00 PM (Regió7). We distinguish two columns:

- [1] Smoke exit by airy patio.
- [2] Smoke exit by main façade.

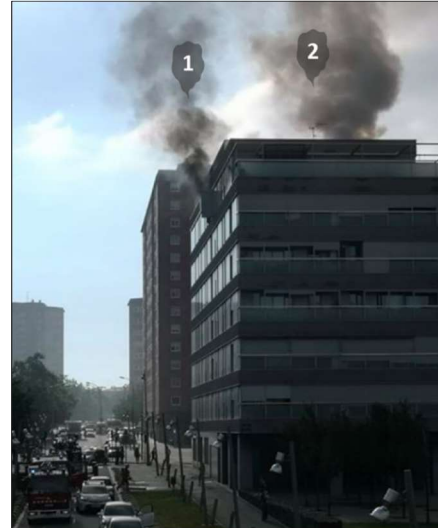
Figure 16. 2019.06.12 Housing fire in Terrassa, started at 08:25 AM (Nació Digital). We distinguish:

- [1] Smoke exit by main façade.
- [2] Smoke exit across inner courtyard.

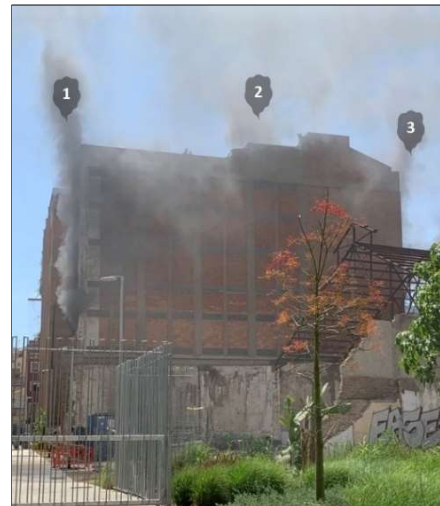
Figure 18. 2019.07.15 Fire in an occupied building in Ciutat de Granada street in Barcelona, started at 12:00 AM (Betevé). We distinguish three columns:

- [1] Smoke exit by back façade.
- [2] Smoke exit by inner courtyard.
- [3] Smoke exit by main façade.

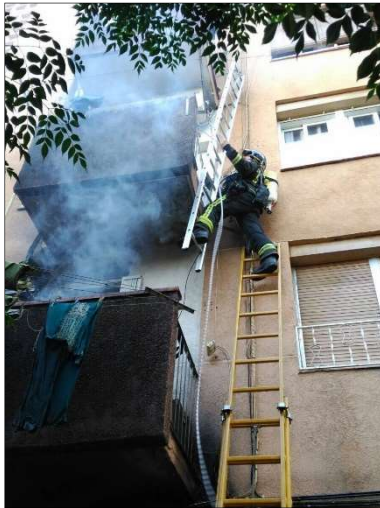
Figure 19. 2016.07.11 Housing fire in Rodés street in Barcelona started at 09:20 AM with the result of two fatalities. Access via manual ladder (J.Abellan).

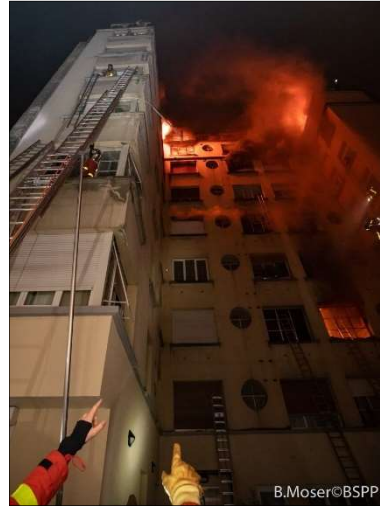
Figure 20. 2019.02.06 Housing fire in Paris started at 01:00 AM with the result of ten fatalities. Rescue by inner courtyard façade via manual ladder (B.Moser©BSPP).

It will depend on how the courtyard is located, the width of the opening, the distance from the street where the ladder truck is located and the presence of street furniture elements (trees, streetlights, etc.) that make it difficult to pass from the basket of the ladder. In the case of Figure 20, the use of the ladder truck was not possible as the mixed airy patio led to an insufficient width passage to fit the truck.

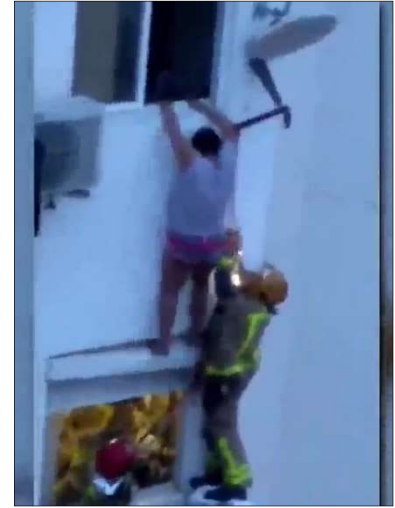
Figure 21. 2019.04.18 Housing fire in Hospitalet started at 06:40 AM with three fatalities. Rescue in extremis through light patio façade (La Vanguardia).

When the fire affects interior airy patios, that is, closed on four sides, the use of a ladder truck for the rescue of people is restricted. The rescuing of people is only possible if they are trapped in areas near façades facing the street. This assumption (Figure 21) is the most complex operating of the following, because if the smoke and heat conditions inside the airy patio get worse, the person will be severely poisoned by smoke.

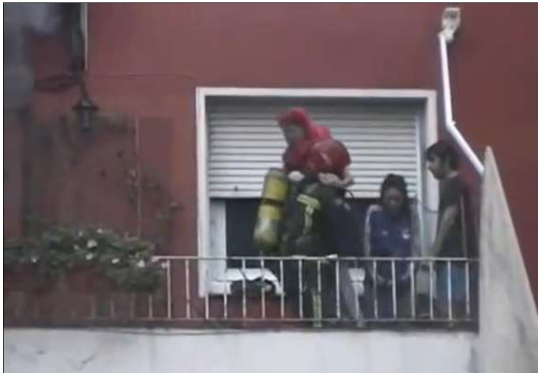
We have a more favorable situation with those looking for refuge on the balconies of the inner courtyard of block (Figure 22), as the building's façade can give them some degree of protection against radiation fire in areas where there are no windows.

Figure 22. 2008.12.26 Housing fire started at 09:00 AM in Ferran Agulló street in Barcelona. Rescue of three young people trapped in the inner courtyard of block (CCMA).

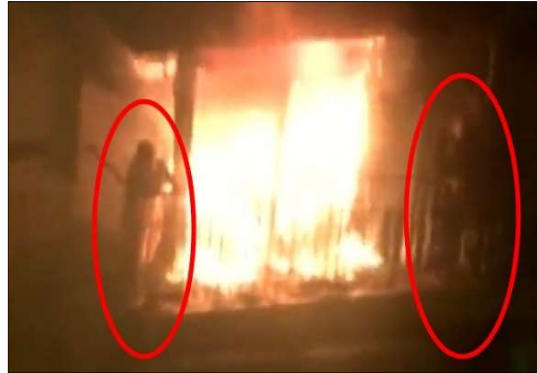
Figure 23. 2016.12.09 Housing fire started at 20:15 PM in Passeig Valldaura street of Barcelona. An older marriage trapped on the balcony were rescued (La Vanguardia).

The use of the balcony as a refuge is circumstantial, if the fire is severe enough or the dimensions of the balcony are small, the victims may be in danger (Figure 23).

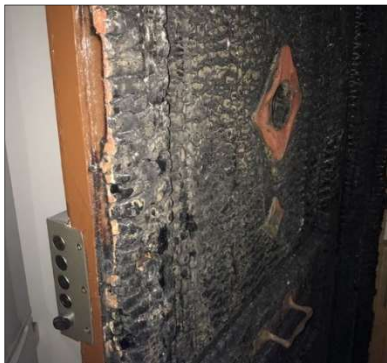
Figure 27. 2018.04.28 Housing fire in Pedró square in Barcelona started at 07:30 PM with the result of a fatal victim (D.Guinart).

Figure 27: The fire on the second floor causes a mortal victim who despite be safe at third floor, decide to run upstairs to the rooftop. When the fire crews arrived, they heard the cry of help of the victim who couldn't leave when they found the roof door locked.

The intense flames coming out of the door of the second-floor apartment prevented, in the first minutes, that the staff could cross the landing to reach the victim. Meanwhile, on the other apartment on the second floor, which had the front door facing the one on the burning floor, this was enough to ensure the confinement of two elderly people who were saved.

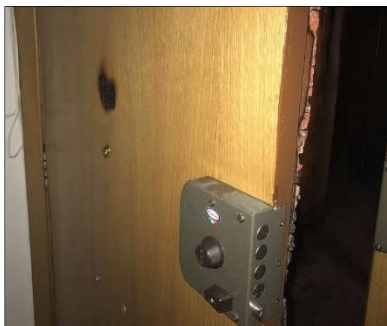
Figure 28. 2018.04.28 Housing fire in Pedró square (D.Guinart).

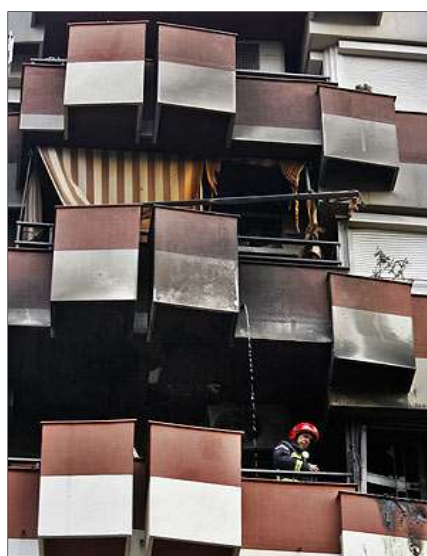
After the fire had been extinguished, during the routine reconnaissance of the building, the bodies of three dead people were found in a seventh-floor flat. The fatalities were one man and one woman found in the floor of the living room) and their son (found in the bathroom of the same flat) who died because of smoke inhalation, that had probably entered the flat through an opened window.

Façade affected by smoke (Avui).

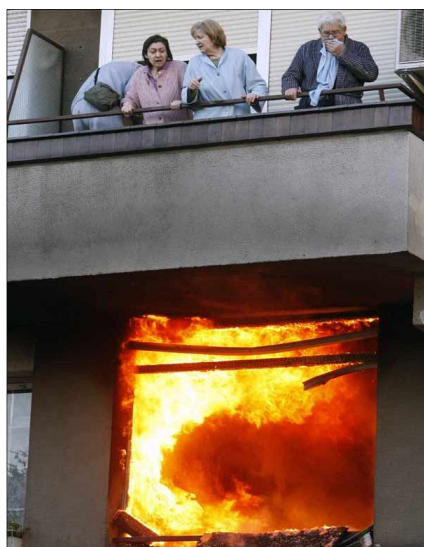
The housing fire started on the mezzanine floor being fully developed. The flames extended further through the light patio and smoking the stairwell. One of the mezzanine floor tenant wasn't be able to leave and died.

External flames on the main façade (El Mundo).

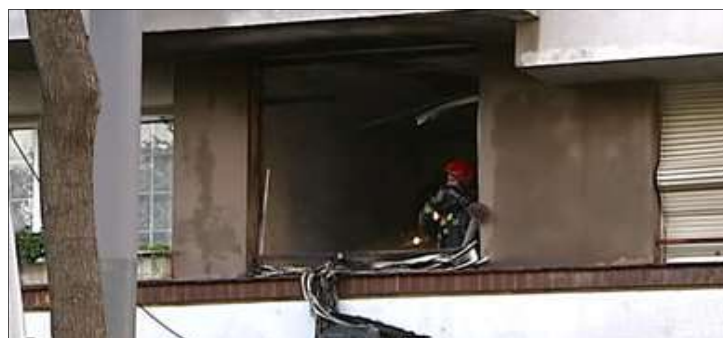
When the firefighters arrived on the scene, the fire was fully developed on the mezzanine's living room and spreaded through the light patio and the stairwell. Due to these, building's electrical, gas, and water service were damaged.

Mezzanine window (CCMA).

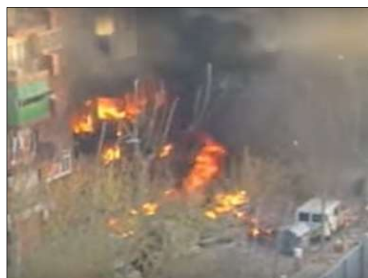
An intentional explosion killed three people and destroyed two flats. Fire spreads through the light patio and the stairwell severely affects the building.

Explosion and subsequent fire (CCMA).

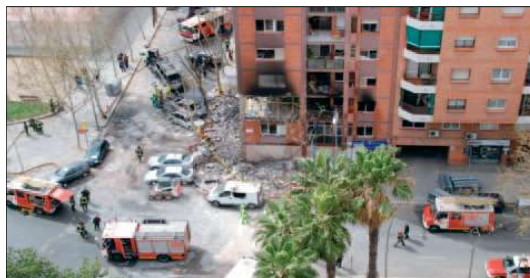
Firefighting crews did multiple rescues of trapped occupants using 2 turntable ladders. The other building occupants remained at home during extinguishing tasks accompanied by firefighters. The fire spread through the light patio and the stairwell and it was so extreme that building's electrical, gas, and water service were damaged as well as all flat doors. There was no damage to the structural integrity of the building.

Wrecked building (Farenheit451).

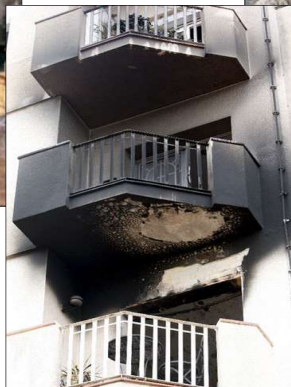
View of the main facade (EFE).

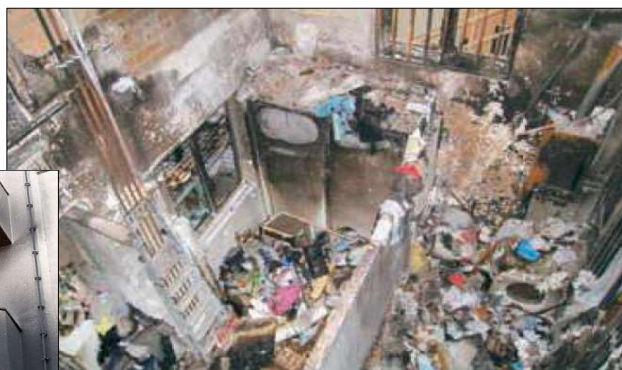
A housing fire started on a 1st floor that spreaded through the airy patio affecting eight flats. The flat's tenant died trying to exit through the stairs.

Airy patio of 28 Mèxic St (Fahrenheit 451).

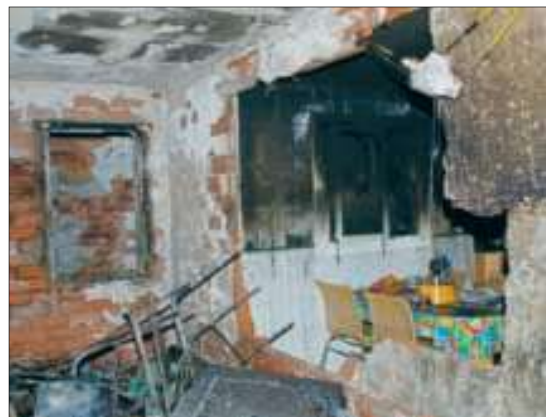
When firefighters arrived on the scene, the fire was fully developed on the 2nd floor. According to the owner - the fire was caused by the explosion of a television - spreading throught the airy patio going up and down. The fire affects the gas facilities which spreaded fire focus along the eight floor galleries. The seventh attic door was completely burned and building's electrical, gas, and water service were damaged.

Affected flat at 594 Còrcega St (Farenheit 451).

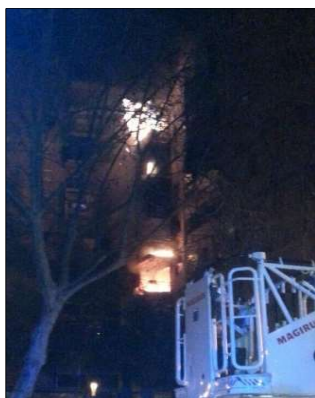
The door of the flat in the highest floor was possibly opened, hence promoting a chimney effect that could have contribute the quick fire spread. This extreme fire behavior phenomena made flames throught the stairwell from third to seventh floor, that burned doors on all landed floors. Fighfighters extinguish the fire using two hoses of 25mm.

Fire spread through the façade (CCMA).

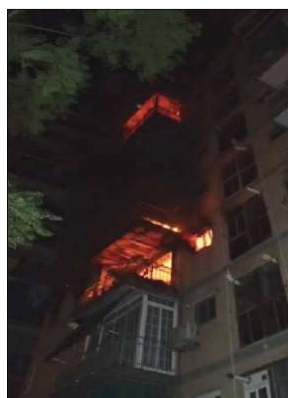
Fire on the 3rd floor (InfoBombers).

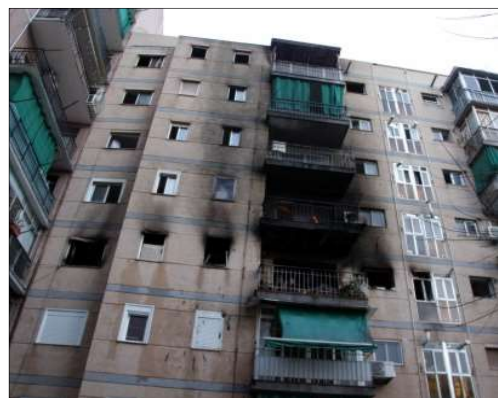
Affected flats on the third, forth and seventh floor (CCMA).

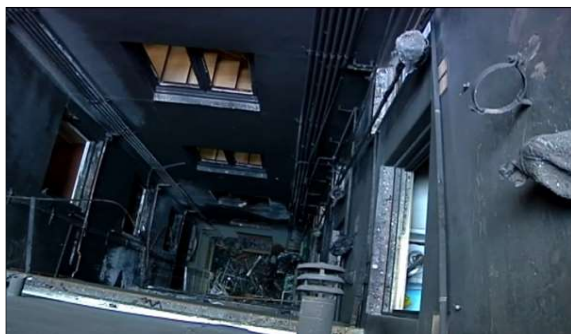
The building has two stairwells A and B linked through their landings. The effect of the vertical suction smoke filled stairwell B and cleaned stairwell A. The occupants of the building left by the free smoke stairwell without getting injured.

Airy patio linked with the B stairwell through the windows (Betevé).

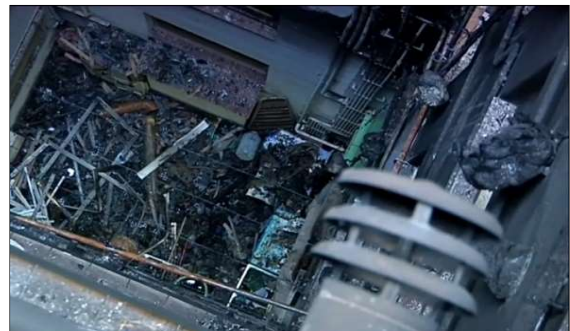
When firefighters arrived on the scene, the fire was fully developed on 3rd floor and spread through the airy patio. All first and third door flats were affected in a different degree as well as the B stairwell. The gas service was damaged.

The airy patio lower part (Betevé).

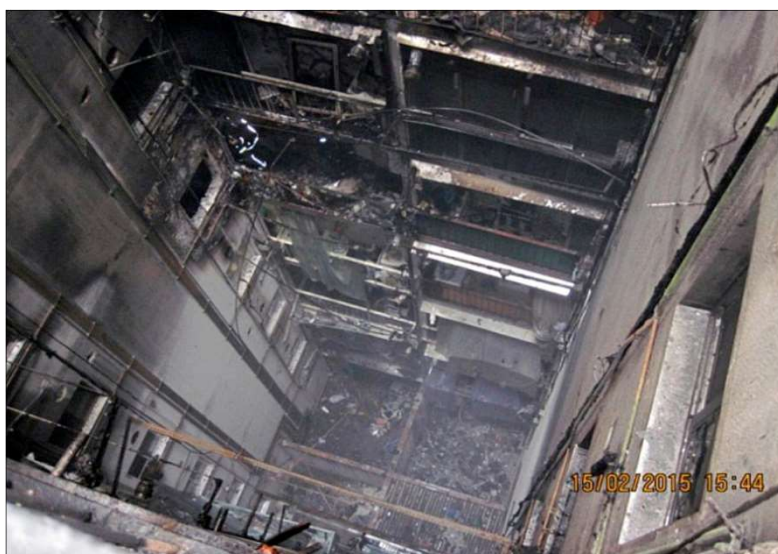
A housing fire started on the 3rd floor and it spread through an airy patio and affected the four floor galleries of two different buildings.

Shared airy patio between blocks number 5 and 7 (Bomberscat).

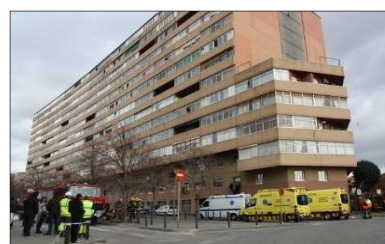
There were flaming debris falling and dropping down tended clothes that contributed to spread the fire upwards and downwards the building. Building's electrical, gas, and phone services were burned as well as all galleries. The fire partially affected the kitchen and a room of 6th floor. Firefighters extinguished the fire using five hoses of 25mm.

Building affected (Bomberscat).

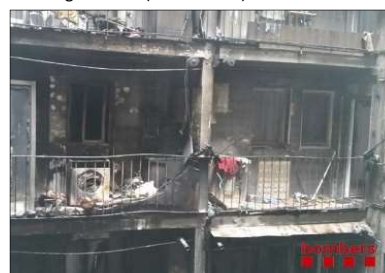
Airy patio galleries (Bomberscat).

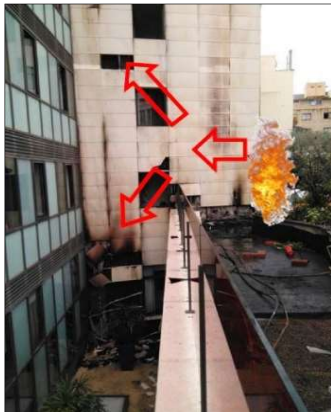
The fire affected the inner surface of the open-joint ventilated façade. The fire spread through the open joints between the panels that compose the outer layer and the smoke attain all façade surface due to the ventilation. The fire was caused during maintenance works on a bituminous waterproofing membrane.

Development of the fire (SPEIS).

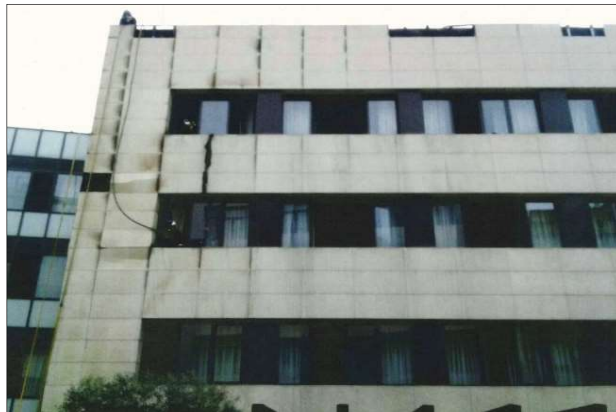
The façade arranged at 90 degrees to each other (SPEIS).

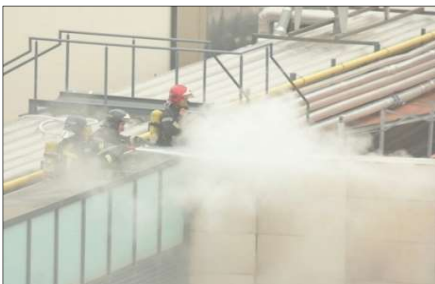
Extinguishing tasks on the building roof (Nació Digital).

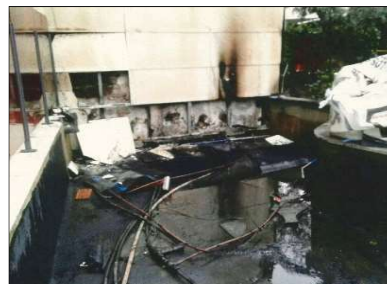
Point where the fire started (SPEIS).

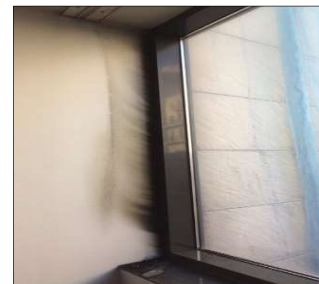
A smoke affected room (SPEIS).

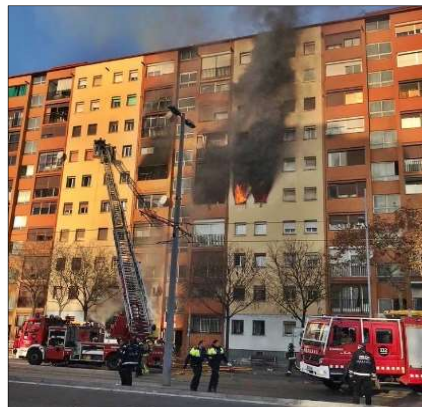
A housing fire started on the ground floor, and it spread across the façade involving upper flats of the building. People from the upper floors tried to escape but they were trapped as the stairwell was full of smoke. Flames came in their flats and three people were found dead.

Development of the external fire (El Confidencial).

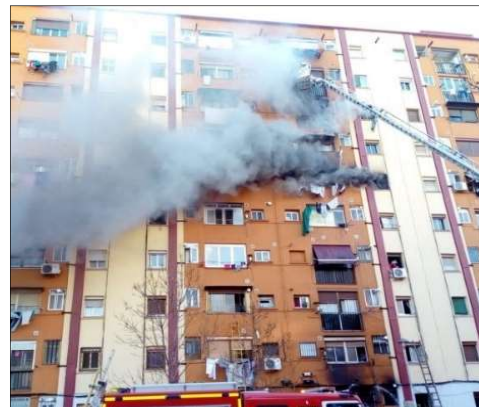
Situation on the rear façade (Diari Badalona).

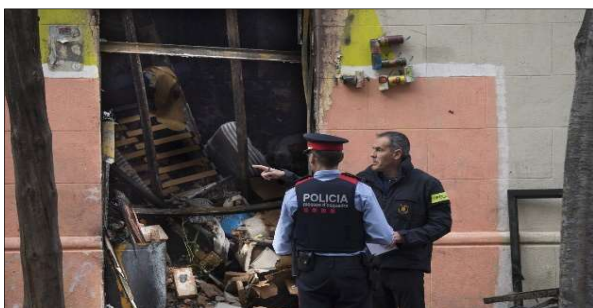
When firefighters arrived on the scene, the fire was fully developed on the ground floor of 45 Enamorats St. The fire had spread along the façade to the floor immediately above, causing the attic of the burning premises and part of the roof of the premises to collapse.

Ground floor of the housing building (M.Sifre).

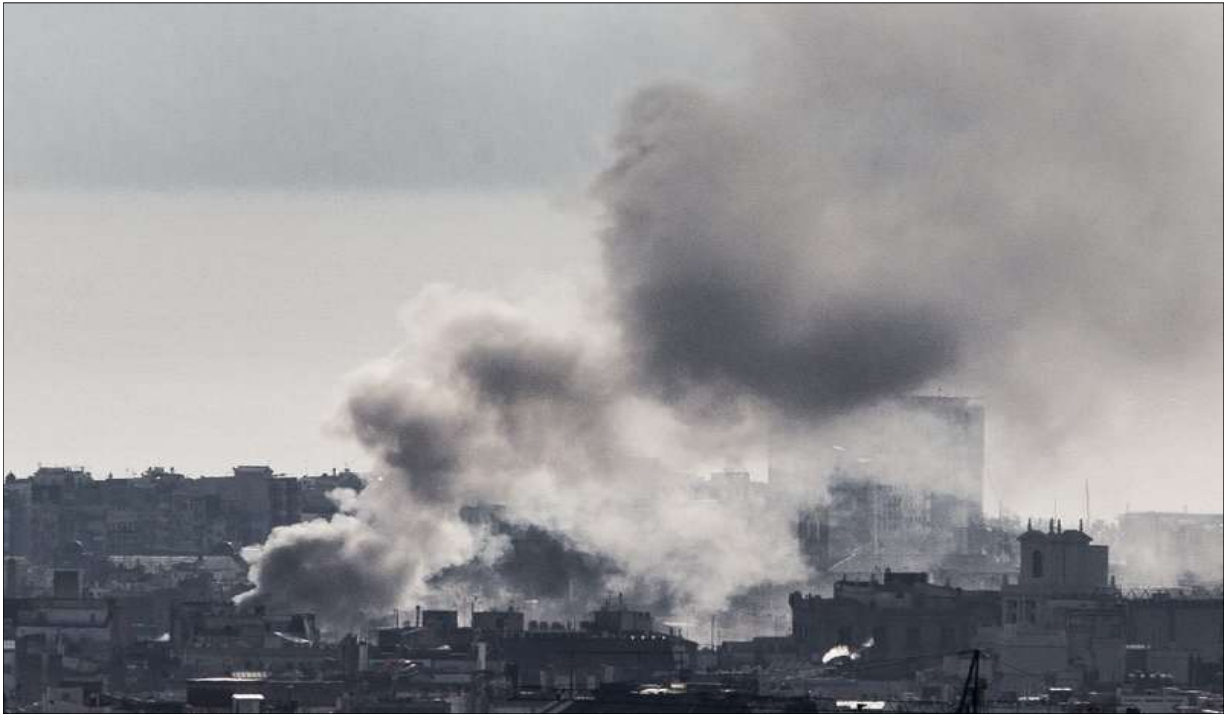
2014/12/16 Images of smoke generated by the fire (unknown author).

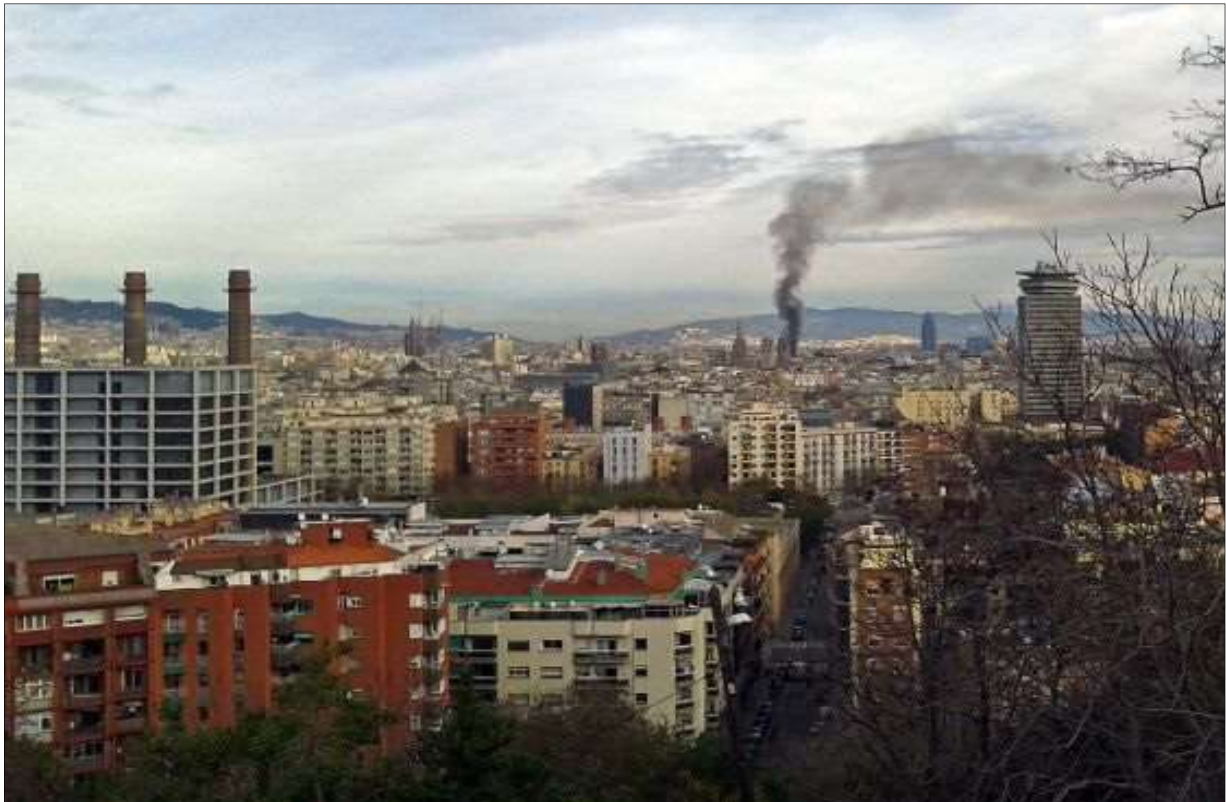
2014/12/16 Column of smoke from the fire seen from Montjuïc (author unknown).

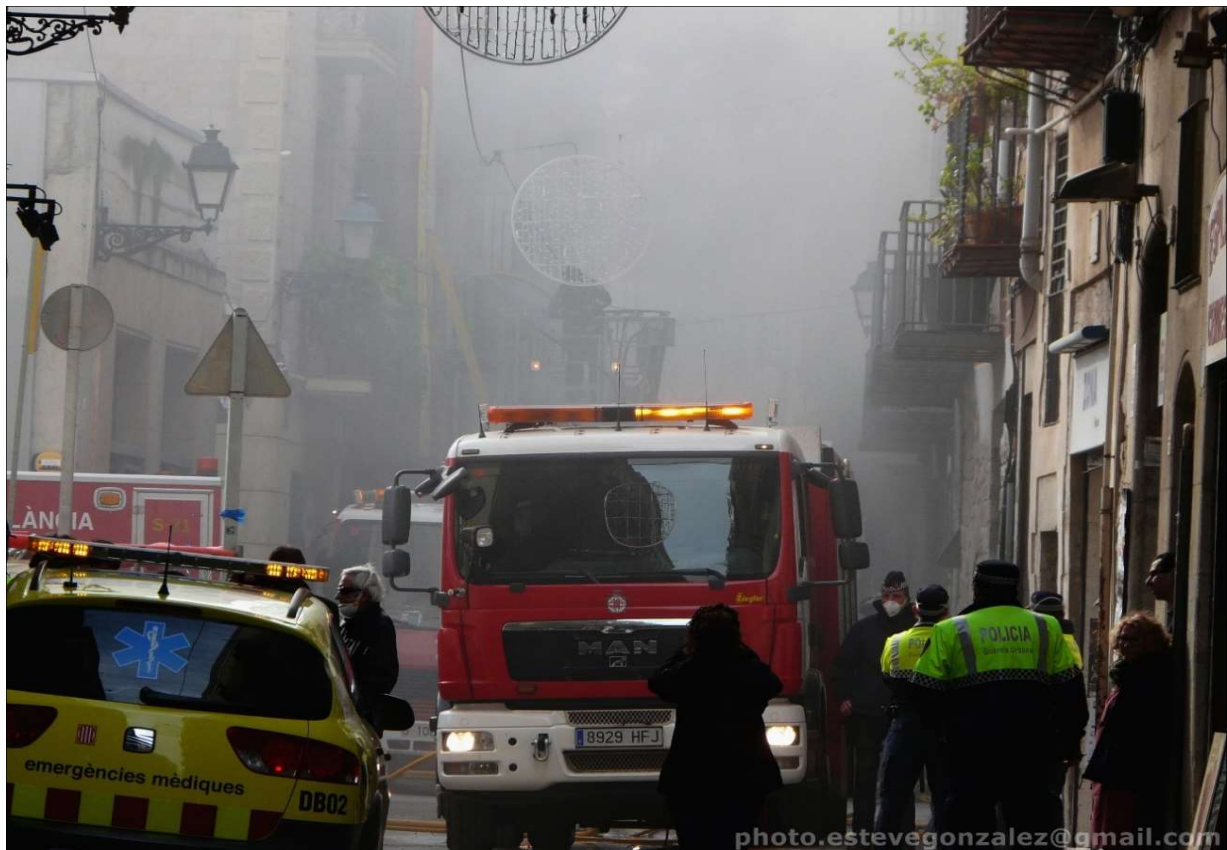
2014/12/16 Situation of the fire at 13:23 from Sant Pere Més Baix St (Author).

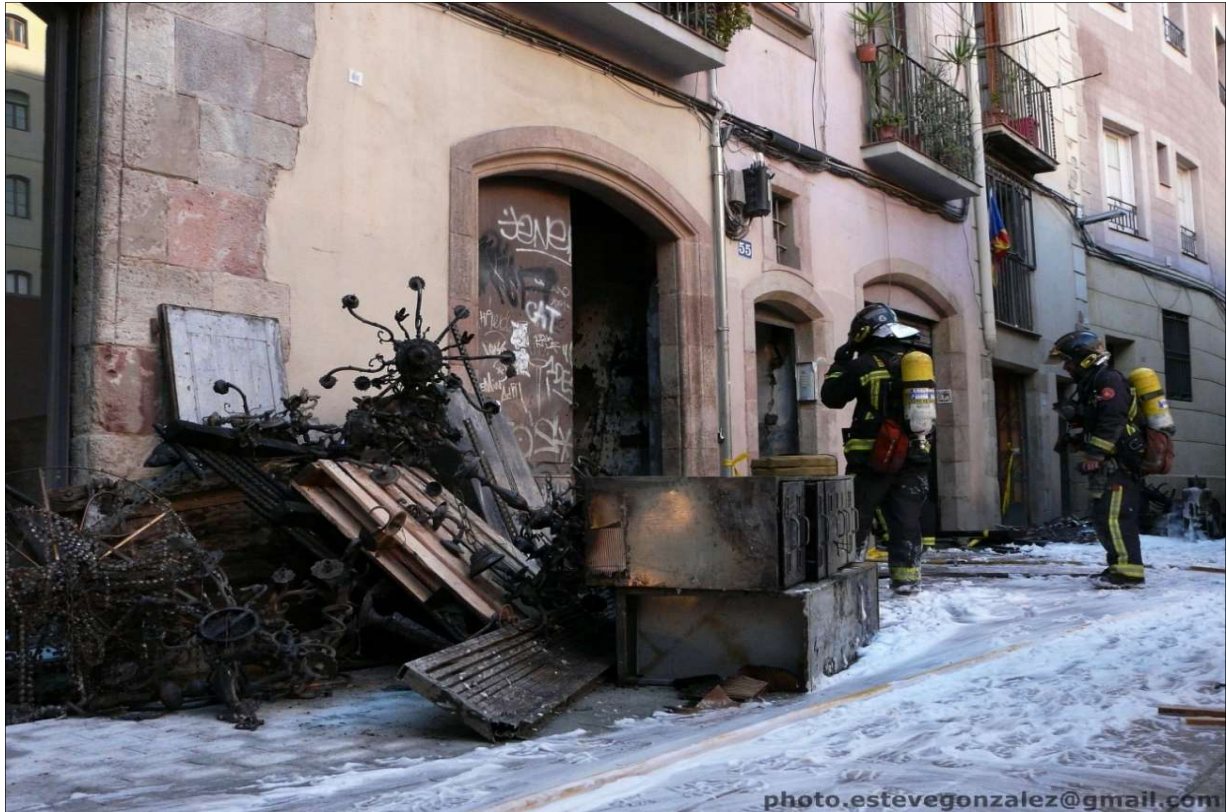
2014/12/16 Material of the interior of the premises at 55 Jaume Giralt St (Author).

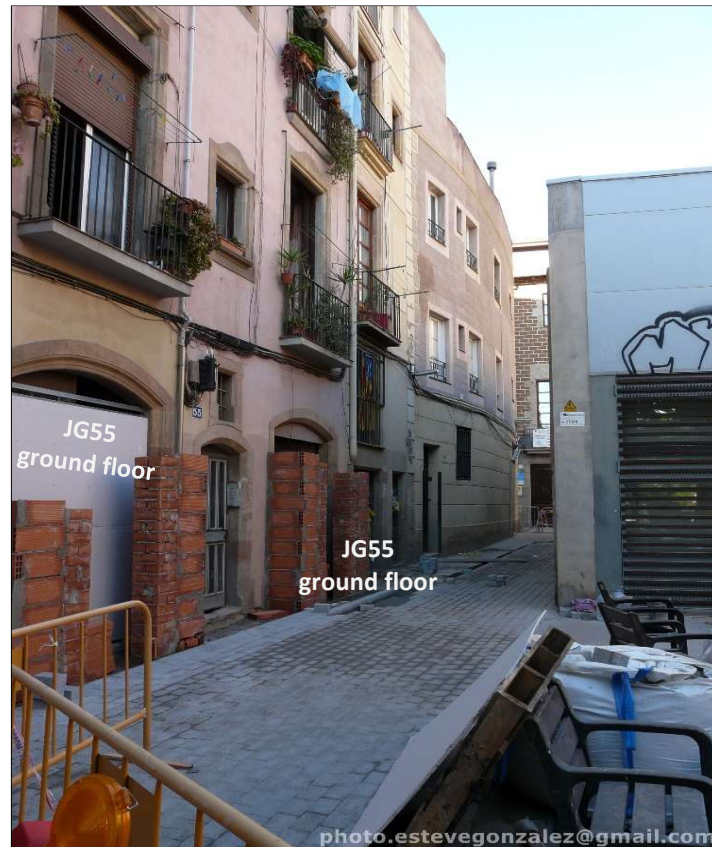
2014/12/21 Walled ground floor at 55 Jaume Giralt St (Author).

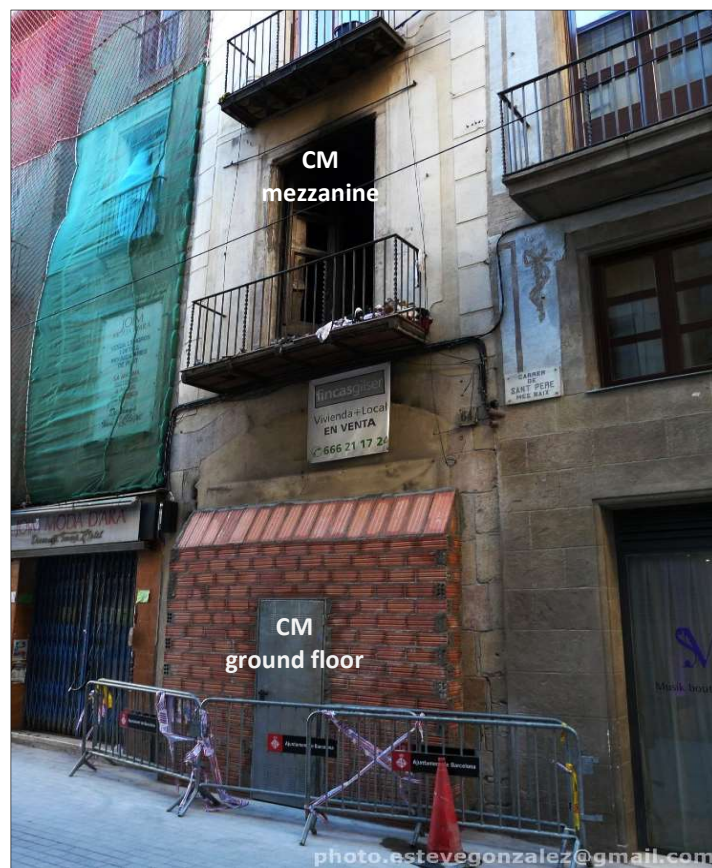
2014/12/21 Walled ground floor at 62 Sant Pere Més Baix St (Author).

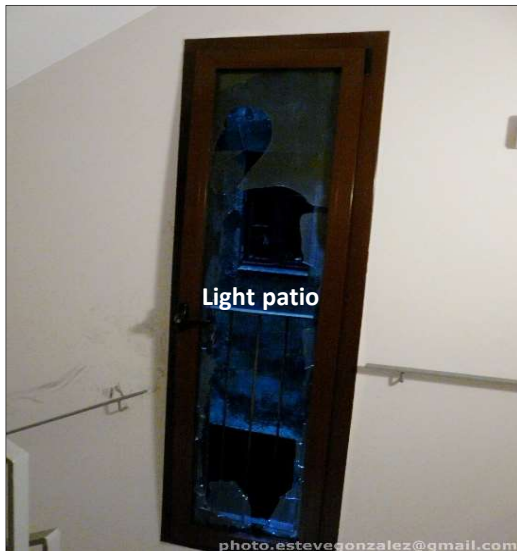
2014/12/21 Protected staircase of the Hotel, first floor window (Author).

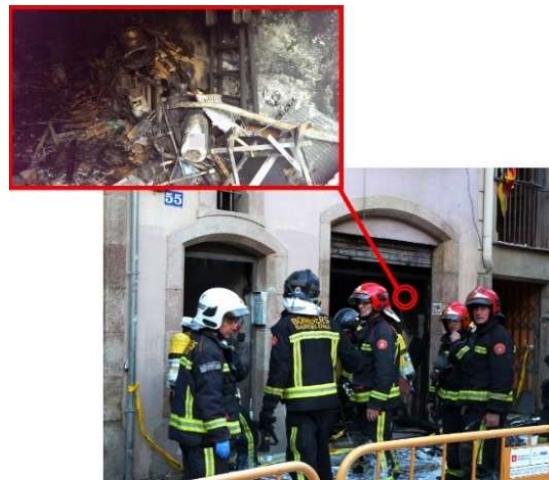
Figure 37. Origin (M.Sellarès & Author).

The causes of the fire and the exact point of the ignition could not be determined with certainty. What is known for sure is that the fire begins in the lower floors of the JG55 building, most likely in an area near the small airy patio. The first call to the emergency services is at 10:07:30 from a landline phone in this building.

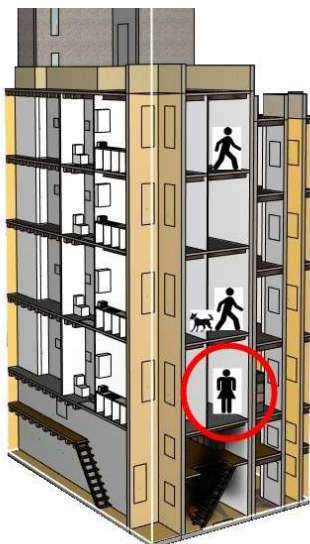
According to the neighbor's testimony, she heard a noise that she initially attributed to the street works. This noise, which she remembers like a creaking noise "as if wooden twigs were breaking" is increased until she gets the feeling of having it inside her home.

Figure 38. Fire origin and the situation of the people. Location of the neighbor marked in red.

That's when she gets out of bed, opens the bedroom door, and the small airy patio window breaks, causing the fall of glass broken on her.

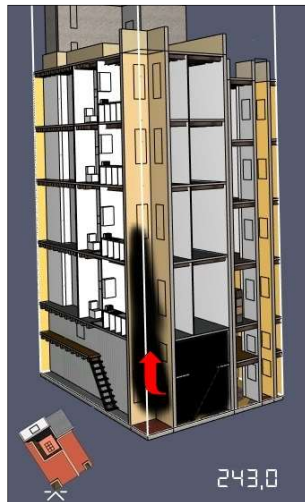
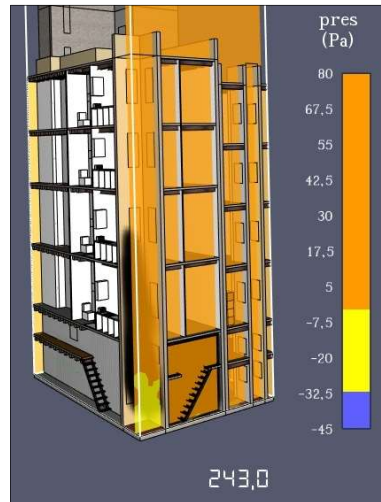
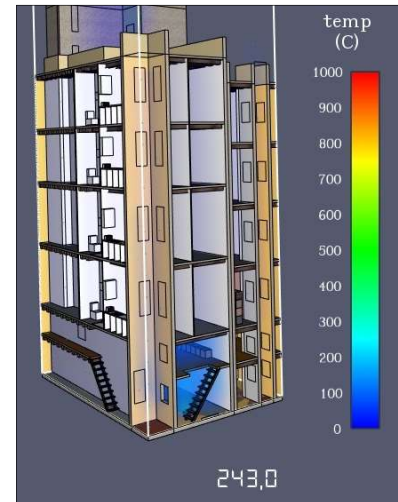
Figure 46. Smoke & flame t=243,0s.

243,0s The window that connects the ground floor 2a with the small airy patio in the JG55 building breaks. **The smoke is sucked out by the fireplace effect through the small airtshaft.**

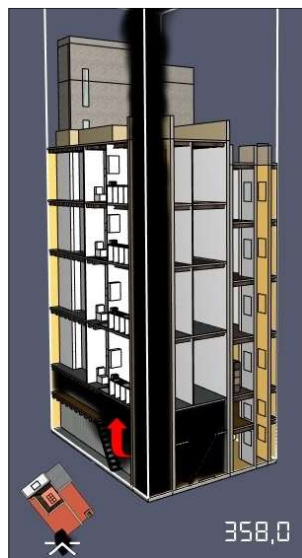
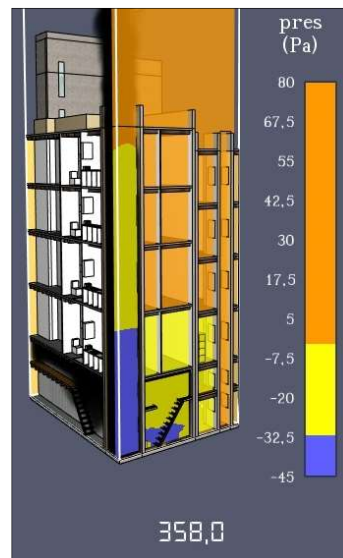
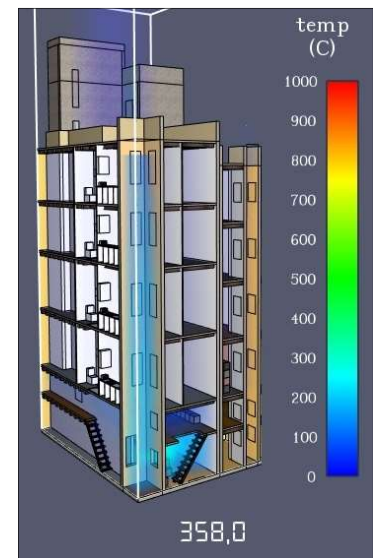
Figure 49. Smoke & flame t=358,0s.

358,0s The gases go up through the small airy patio breaking the windows enabling the entry of **smoke into the ground floor and the 2nd doors**. The neutral pressure plane of the airy patio is located almost at the highest point of the building.

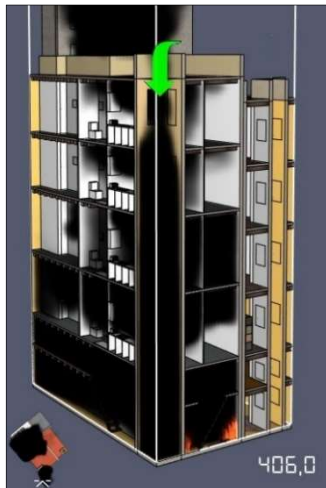
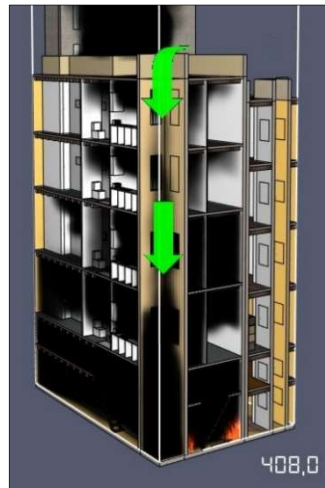
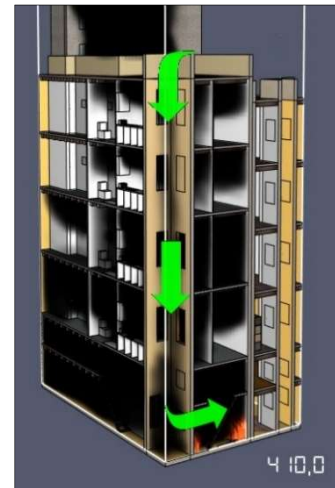
Figure 52. Smoke &amp; flame t=406,0s.

**The skylight of the light patio breaks down.** The exit of smoke and flames through it generates a negative pressure inside the fire which reverses the sense of air circulation through the small airy patio, inducing the general combustion of the whole enclosure. The change in the direction of air circulation through the airy patio causes a drop of temperature, as shown Graph 1.

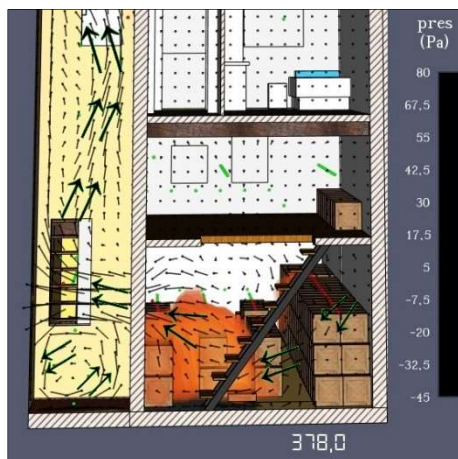
Figure 55. Pressure vectors at t = 378.0s (before the light patio breaks).

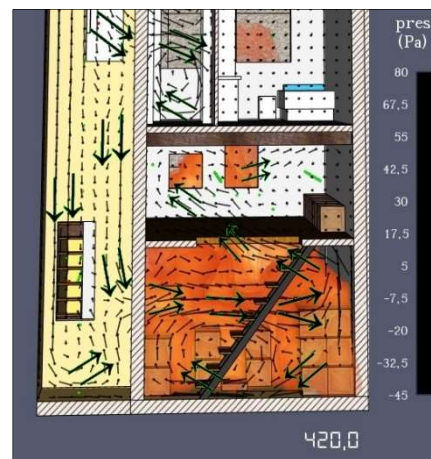
Figure 56. Pressure vectors at t = 420.0s (with light patio open).

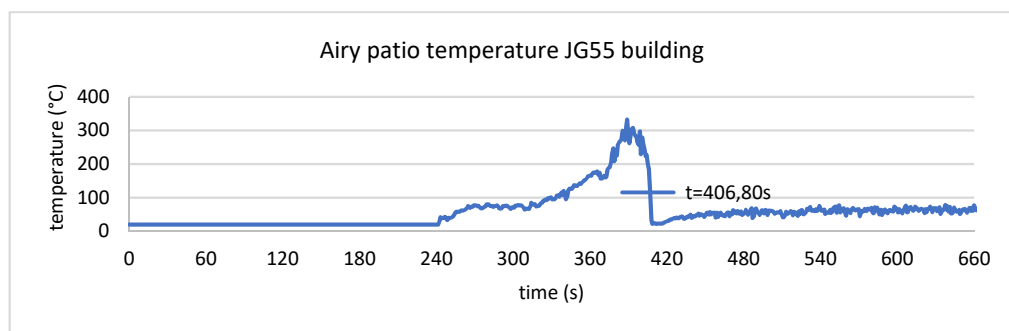
Graph 1. Evolution of the temperature inside the small airy patio JG55 at a point 8 meters high.

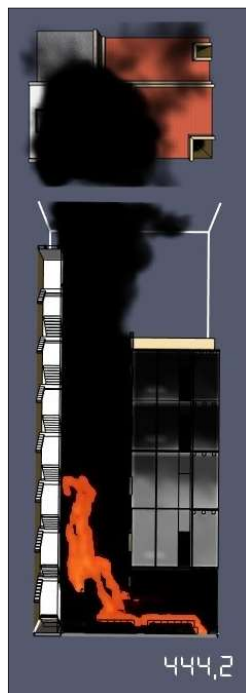
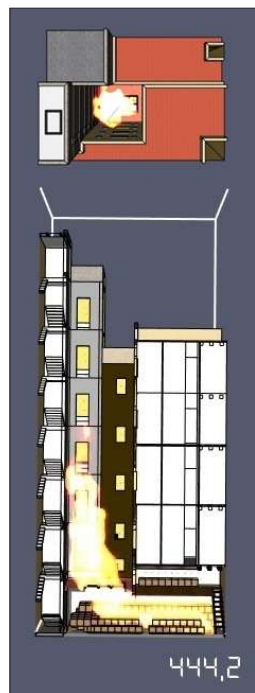
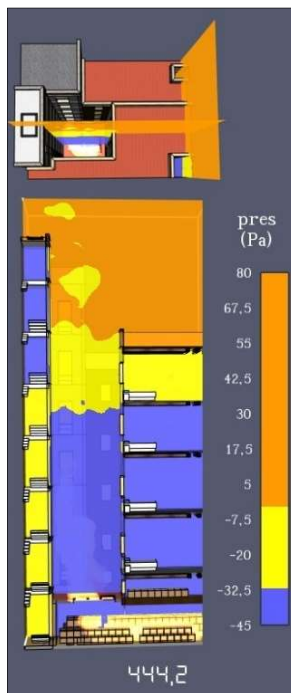
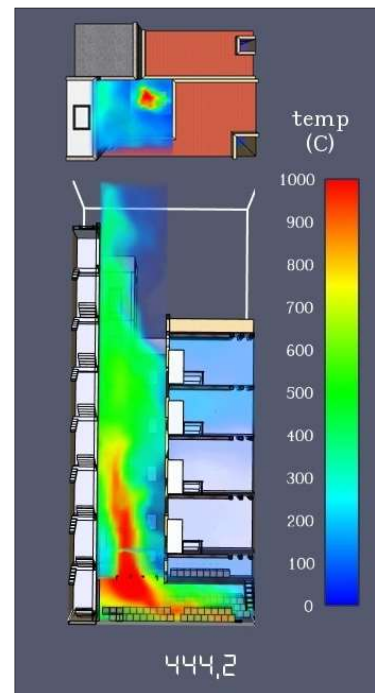
Figure 57. Smoke and flame t=444,2s.

Figure 58. Flame t=444,2s.

Figure 59. Pressure and flame t=444,2s.

Figure 60. Temperature t=444,2s.

444,2s **Flashover occurs on the 2nd ground floor** causing the exit of smoke and flames with virulence through the light patio. The neutral pressure plane is maintained at roof level. The beams of the ground floor closer to the light patio are structurally affected.

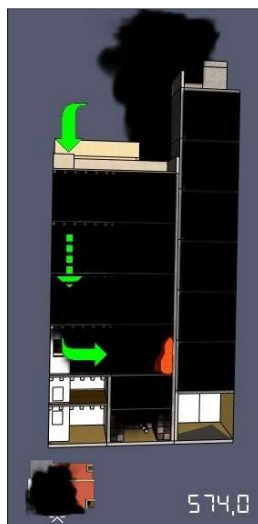
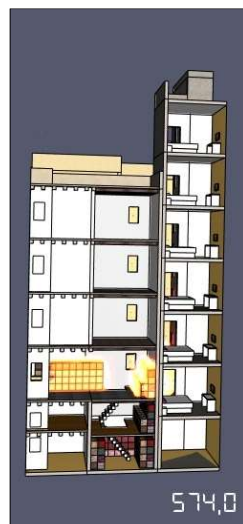
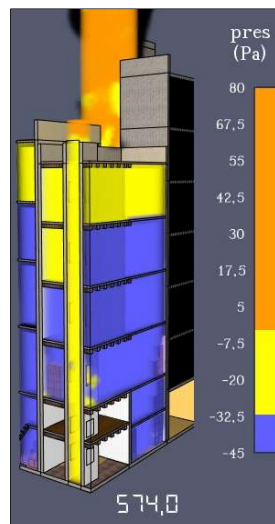
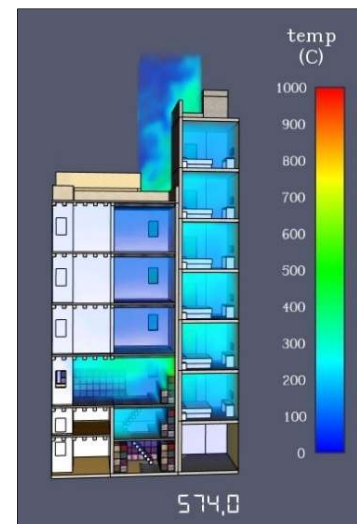
Figure 61. Smoke and flame t=574,0s.

Figure 62. Flame t=574,0s.

Figure 63. Pressure and smoke t=574,0s.

Figure 64. Temperature t=574,0s.

574,0s **Flashover occurs on the first floor of the CM building** when the window that connects to the small airy patio JG55 is broken. As in the case of JG55, the air enters through the small airy patio and smoke and flames go out through the windows overlooking the light patio.

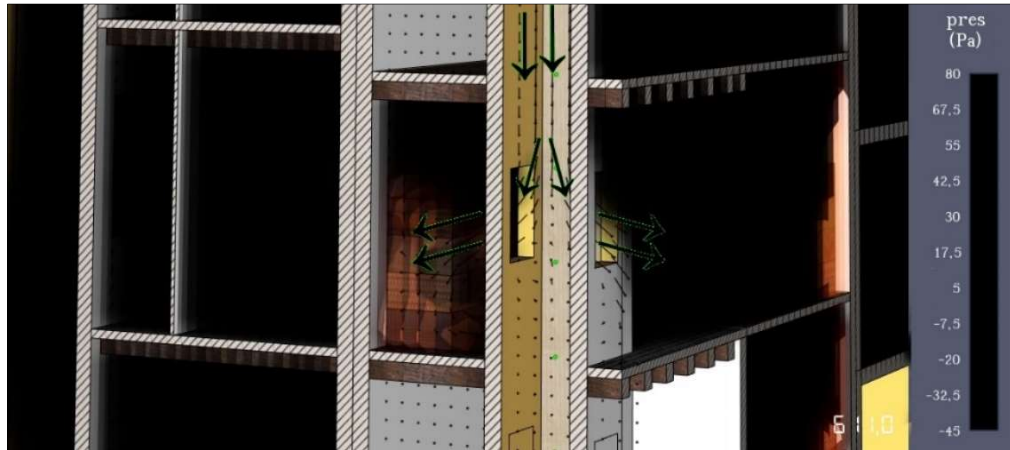
Figure 65. Pressure vectors with window breaking at  $t = 611.0s$ .

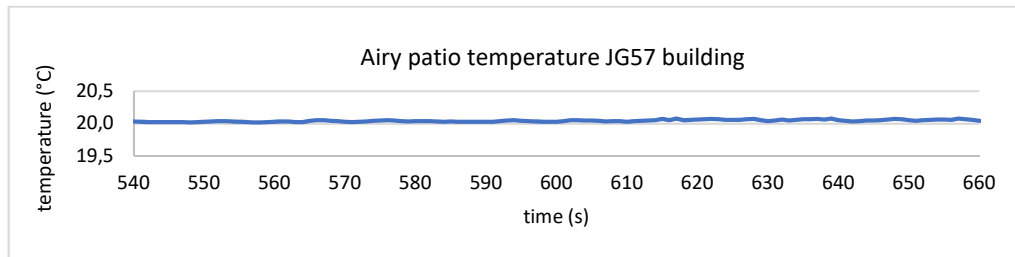
The temperature variation inside the small airy patio of JG57 is minimal because the clean air that circulates comes directly from the outside and does so at ambient temperature.

Graph 2. Evolution of the temperature at the outlet of the small airy patio JG57 (18 meters high).

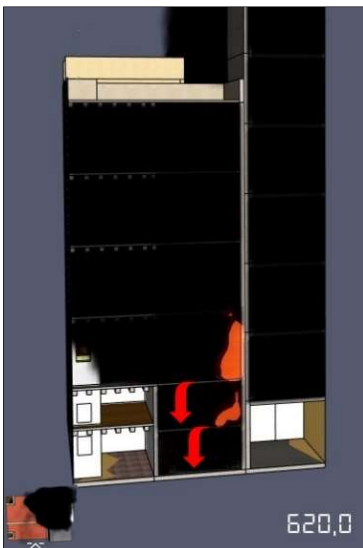
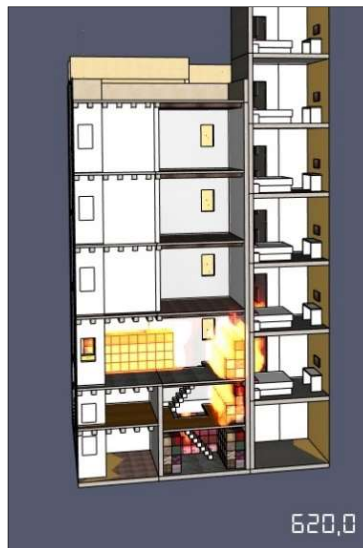
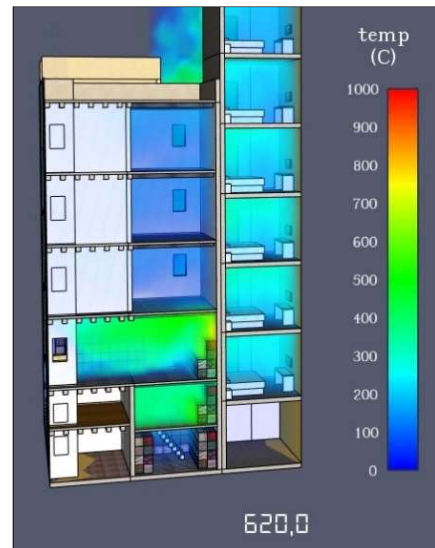
Figure 66. Smoke & flame  $t=620.0s$ .

Figure 67. Flame  $t=620.0s$ .

Figure 68. Temperature  $t=620.0s$ .

620,0s The fire then spreads down the stair hole, initiating **flashover on the loft and on the ground floor of the CM building**. The stairwell vault fell during firefighting operations without being injured.

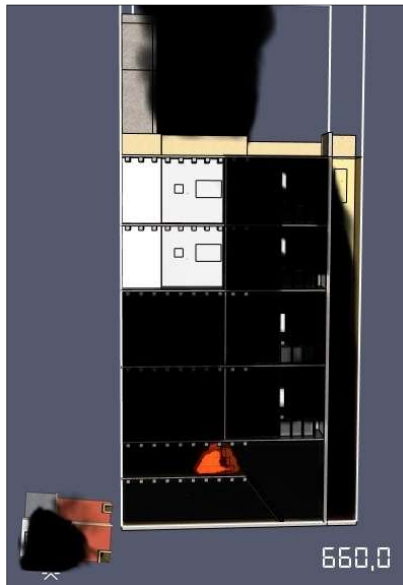
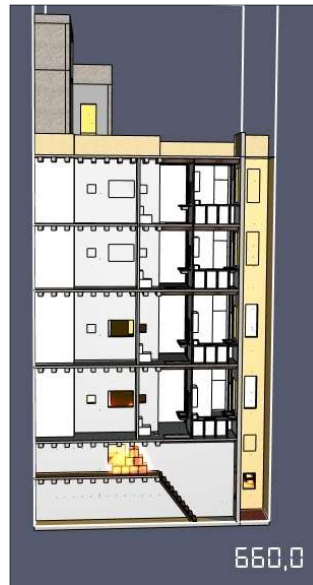
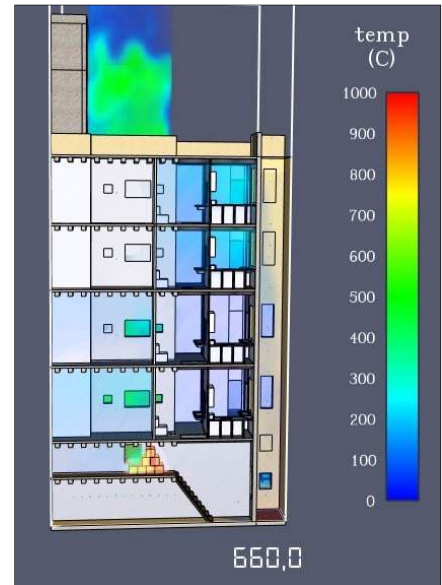
Figure 69. Smoke &amp; flame t=660,0s.

Figure 70. Flame t=660,0s.

Figure 71. Temperature t=660,0s.

660,0s **Flashover occurs on the loft 1st of the JG55 building, spreading to the ground floor with which it communicates directly.**

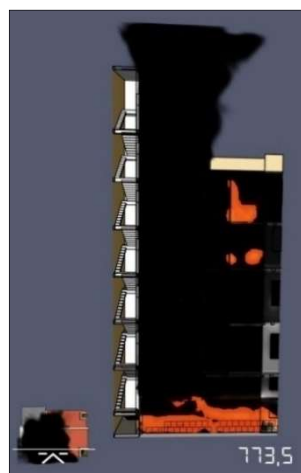
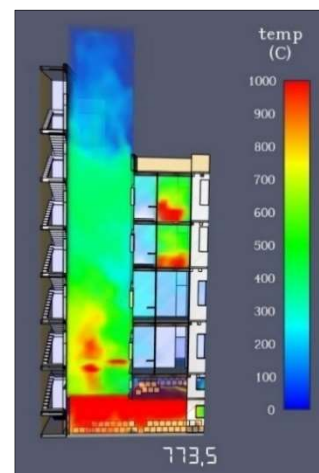
Notwithstanding this, beyond the 660 seconds of simulation there is a flashover on the 3r2a and 4t2a kitchens of the JG55 building. However, this does not happen despite being consistent with the temperature values recorded inside the flats.

Figure 72. Smoke &amp; flame t=773,5s.

Figure 73. Temperature t=773,5s.
